**Ridge Landfill Expansion:  
Assessment of Potential Bird Hazards  
to Aircraft Safety**

Appendix D4

January 2020

LGL Report No. FA0099-1

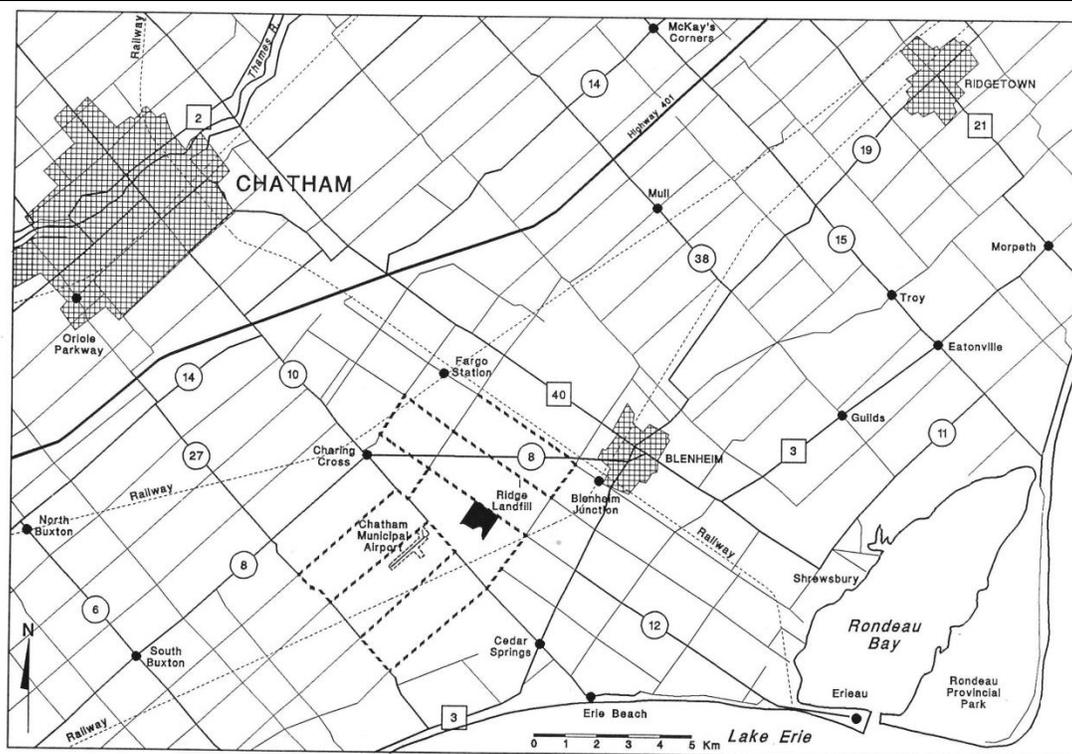
Figure 2. Study area showing Ridge Landfill, Chatham Municipal Airport and the agricultural field survey.

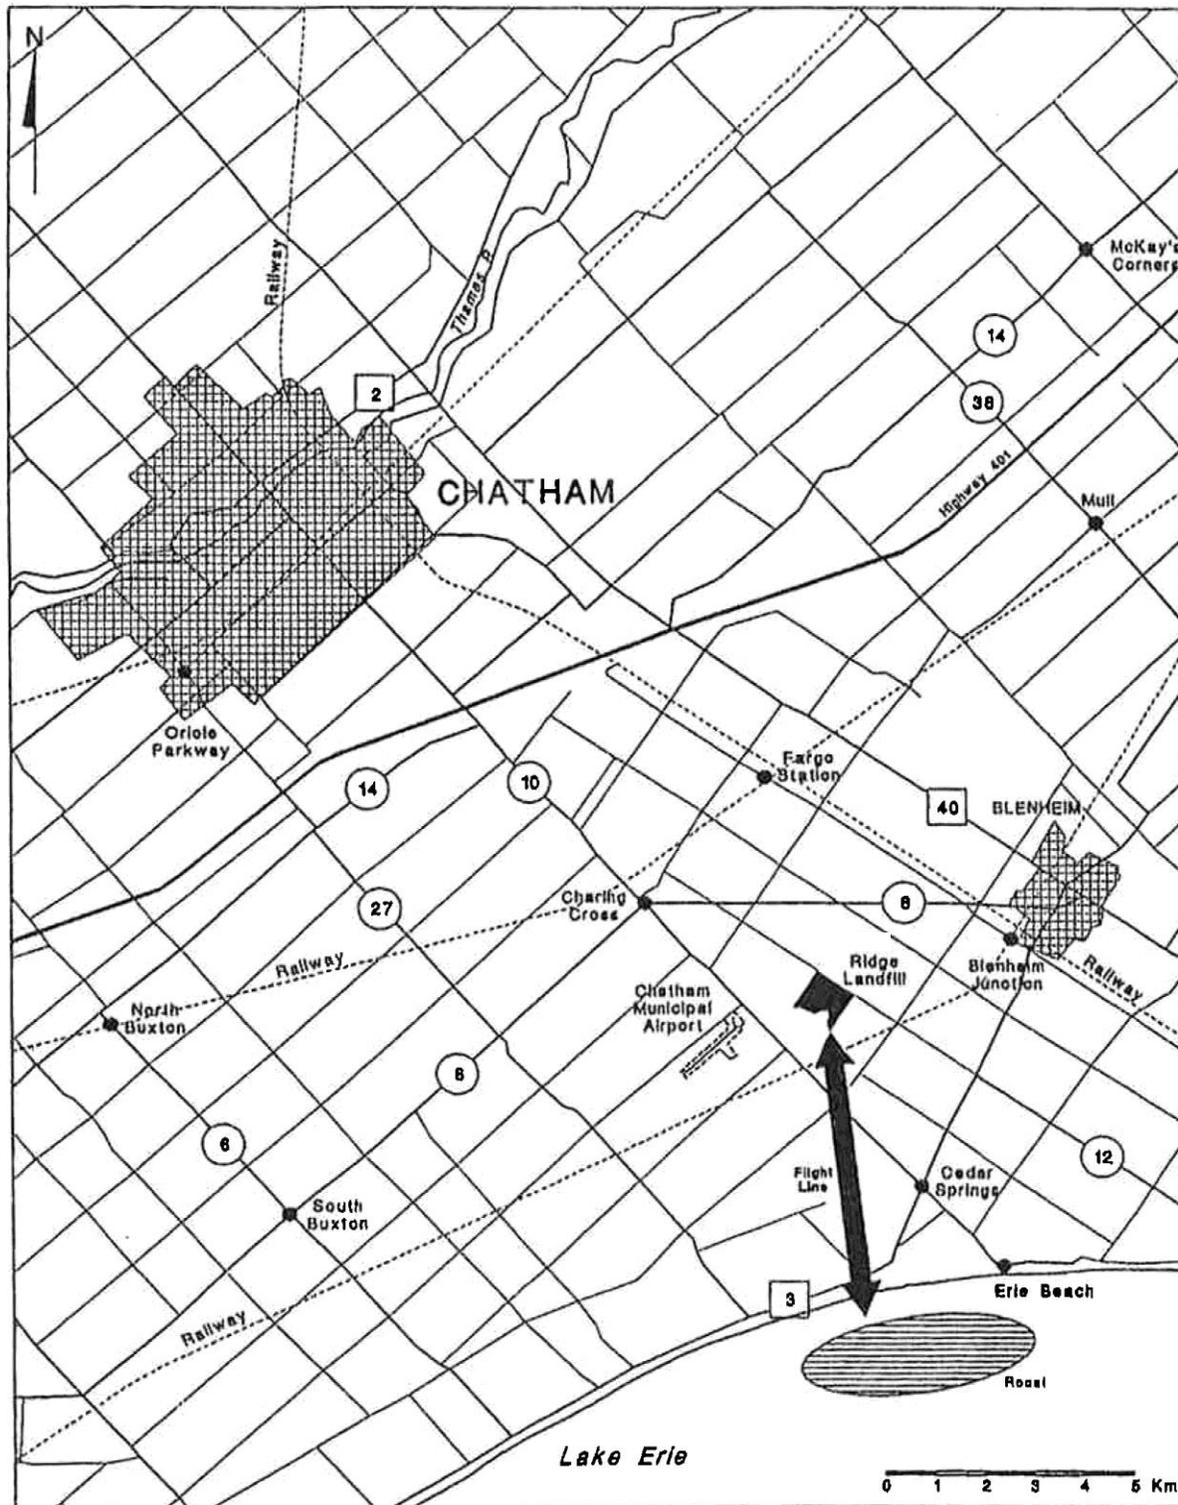
Figure 3. Generalized flightline and roost site of gulls during 1995 study and 2016/2017 study.

Gulls were observed leaving the landfill on the afternoon of 23 November 2016 and were followed to the night roost (Figure 3). Some gulls headed south down Charing Cross Road toward the lake, while others first headed west along 15<sup>th</sup> Line (south of the airfield), stopping to loaf in agricultural fields briefly, before continuing south to Lake Erie, roughly due south from Cedar Springs. This roost is roughly in the same location as the roost located during the 1996 study (Davis et al 1996). In the afternoon of 27 February 2017, up to 1,500 gulls gathered in wet fields between Erieau Road, Bisnett Line and Erieau Shores Drive. Gulls arrived at this location throughout the afternoon; as sunset approached a few gulls trickled out to the lake in small groups. At 6:17 PM, 2 minutes before sunset, all of the gulls took off and flew out to the lake in large, tight groups.

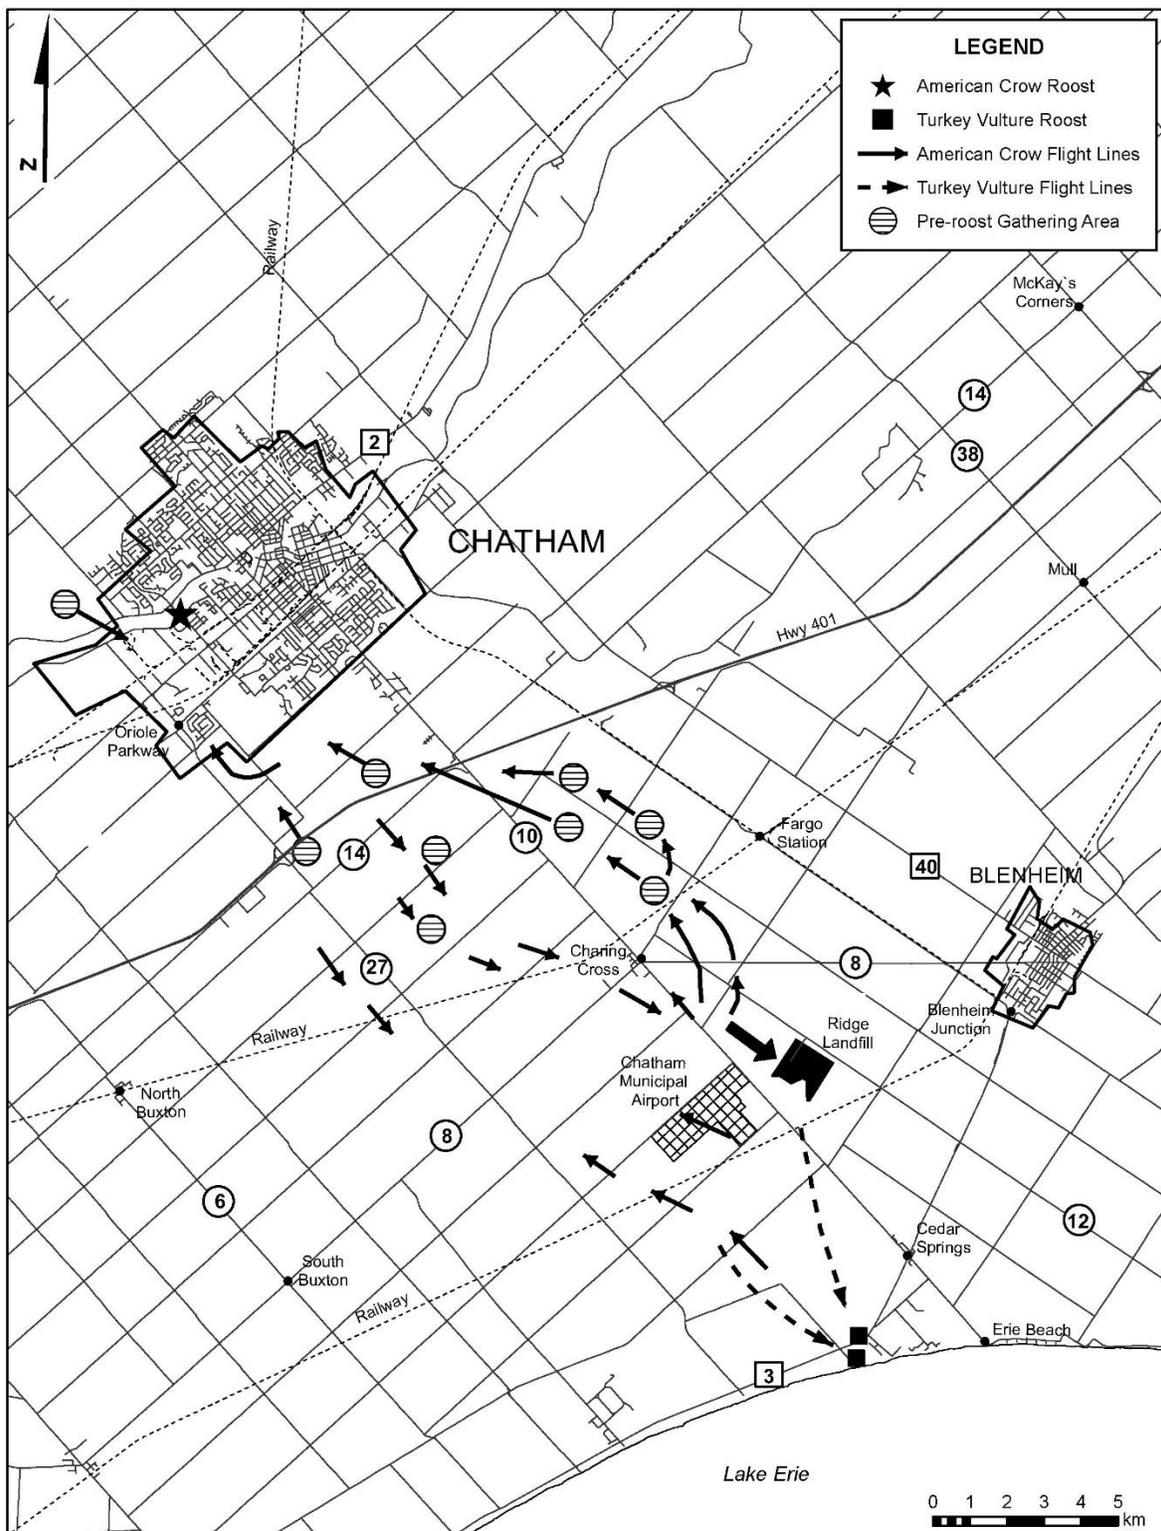
Figure 4. Flightlines and night roost sites used by American Crows and Turkey Vultures in 2016-2017.

On 28 February 2017, a survey of the area north of the landfill was conducted to discover crow flightlines to the landfill. Roughly 500 crows were seen moving in small groups from the general direction of Chatham. It is likely that not all were heading directly to the landfill but most were moving southeast. The crows flew low across fields or moved along hedgerows, stopping frequently along their route. That evening crows were followed to their night roost in Chatham. At 5:00 PM a major pre-roost concentration of 1,400 crows was found in a field on Bloomfield Road, just south of Highway 401. From there crows were followed into Chatham where they were converging on the trees along the Thames River, in the vicinity of the Kiel Drive Bridge. Crows were also found roosting in a woodlot behind a factory on Richmond Street, roughly 500 metres southwest of Kiel Drive Bridge. There were approximately 5,000 crows roosting in these two locations (Figure 4).

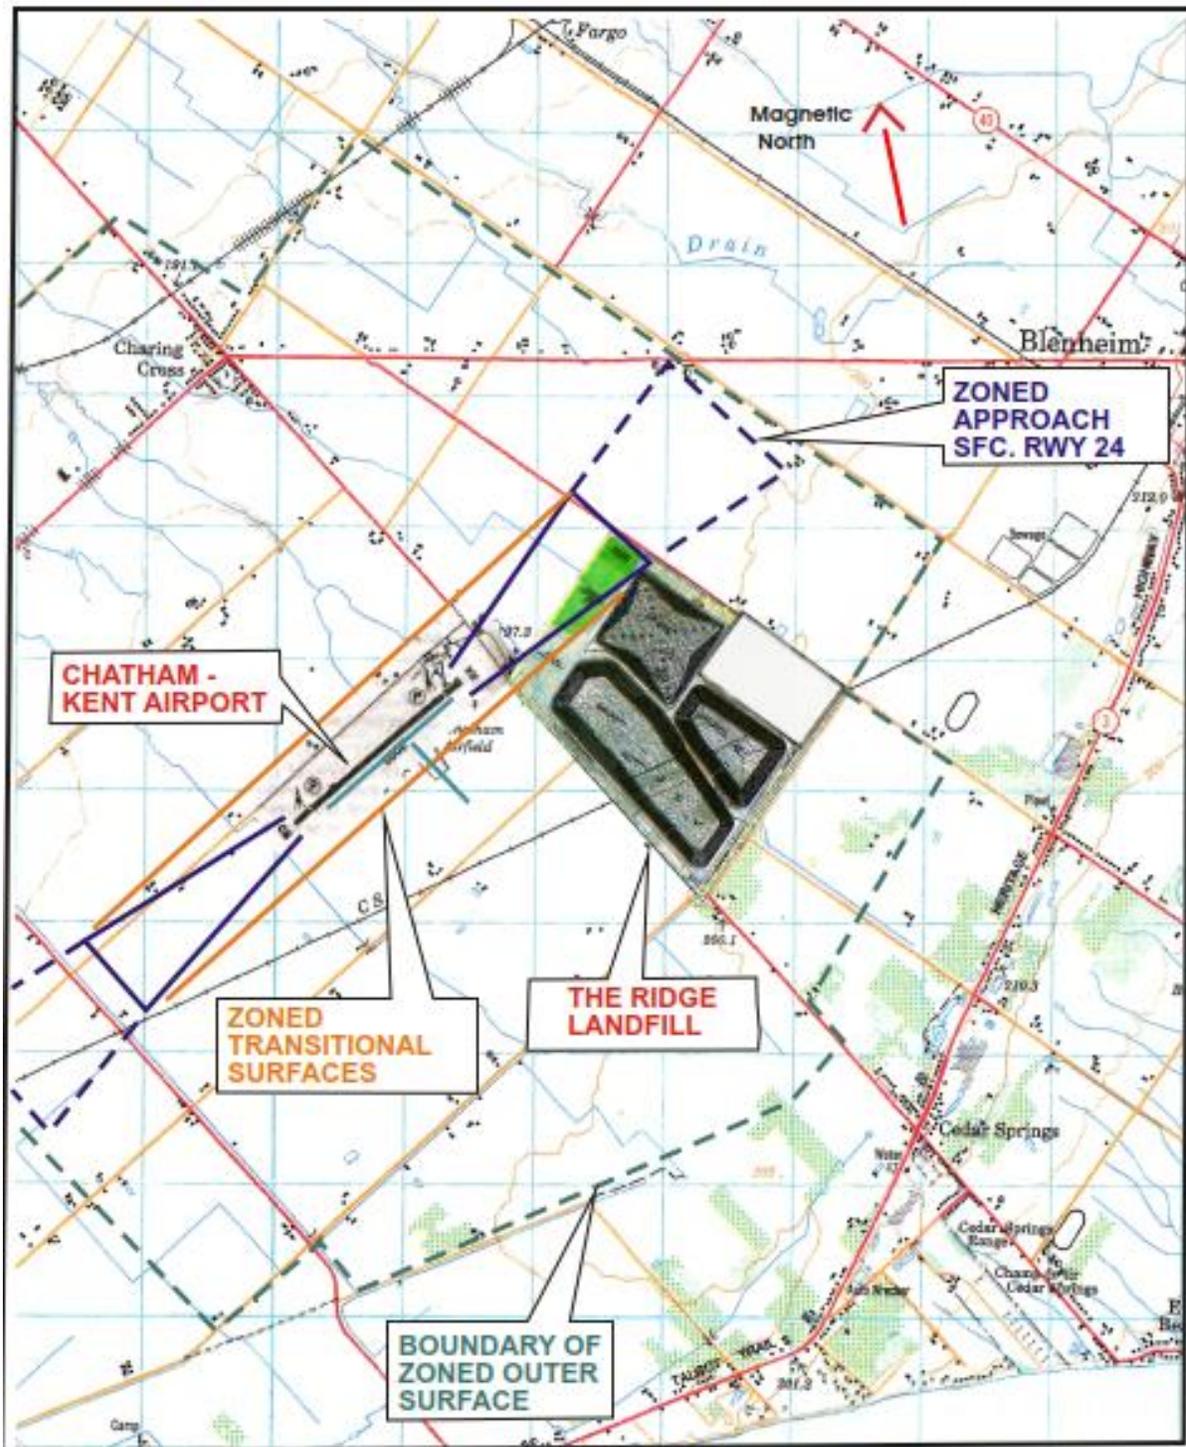
**MAP "A" CHATHAM- KENT MUNICIPAL AIRPORT  
AND AIRPORT REGISTERED ZONING**  
(As Of February 23, 2019)

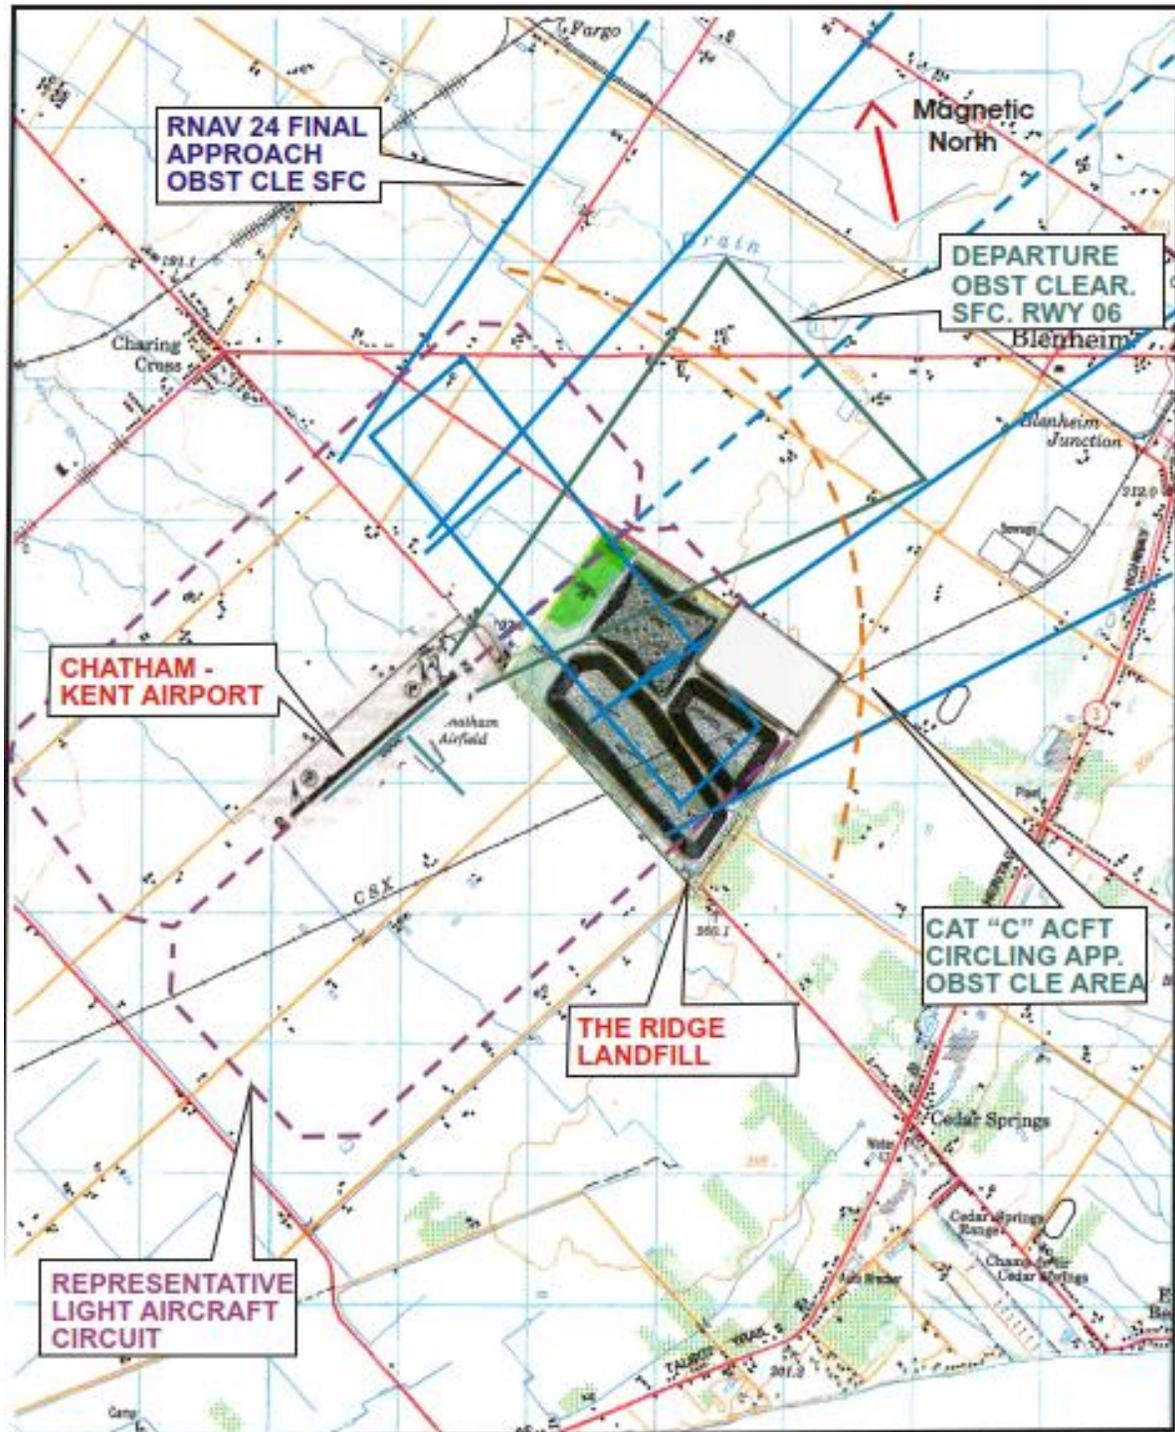
**MAP "B" CHATHAM-KENT MUNICIPAL AIRPORT  
AND FLIGHT PROTECTED SURFACES**  
(As Of February 23, 2019)

Figure 6 (Map B) illustrates a Representative Light Aircraft Circuit area for the paved runway in both directions, normally flown at 305 m above ground, when in the downwind abeam the runway, except for the climbing turns after take-off, or the final turns prior to landing. Pilots are aware of the wildlife caution as contained in the Chatham-Kent Airport listing in the Canada Flight Supplement. The representatives of the St. Thomas Flight Centre did indicate that much of the training and sight-seeing flying is done away from the vicinity of the Chatham Kent Airport and at heights above the 305 m circuit height (Figure 6, Map B).

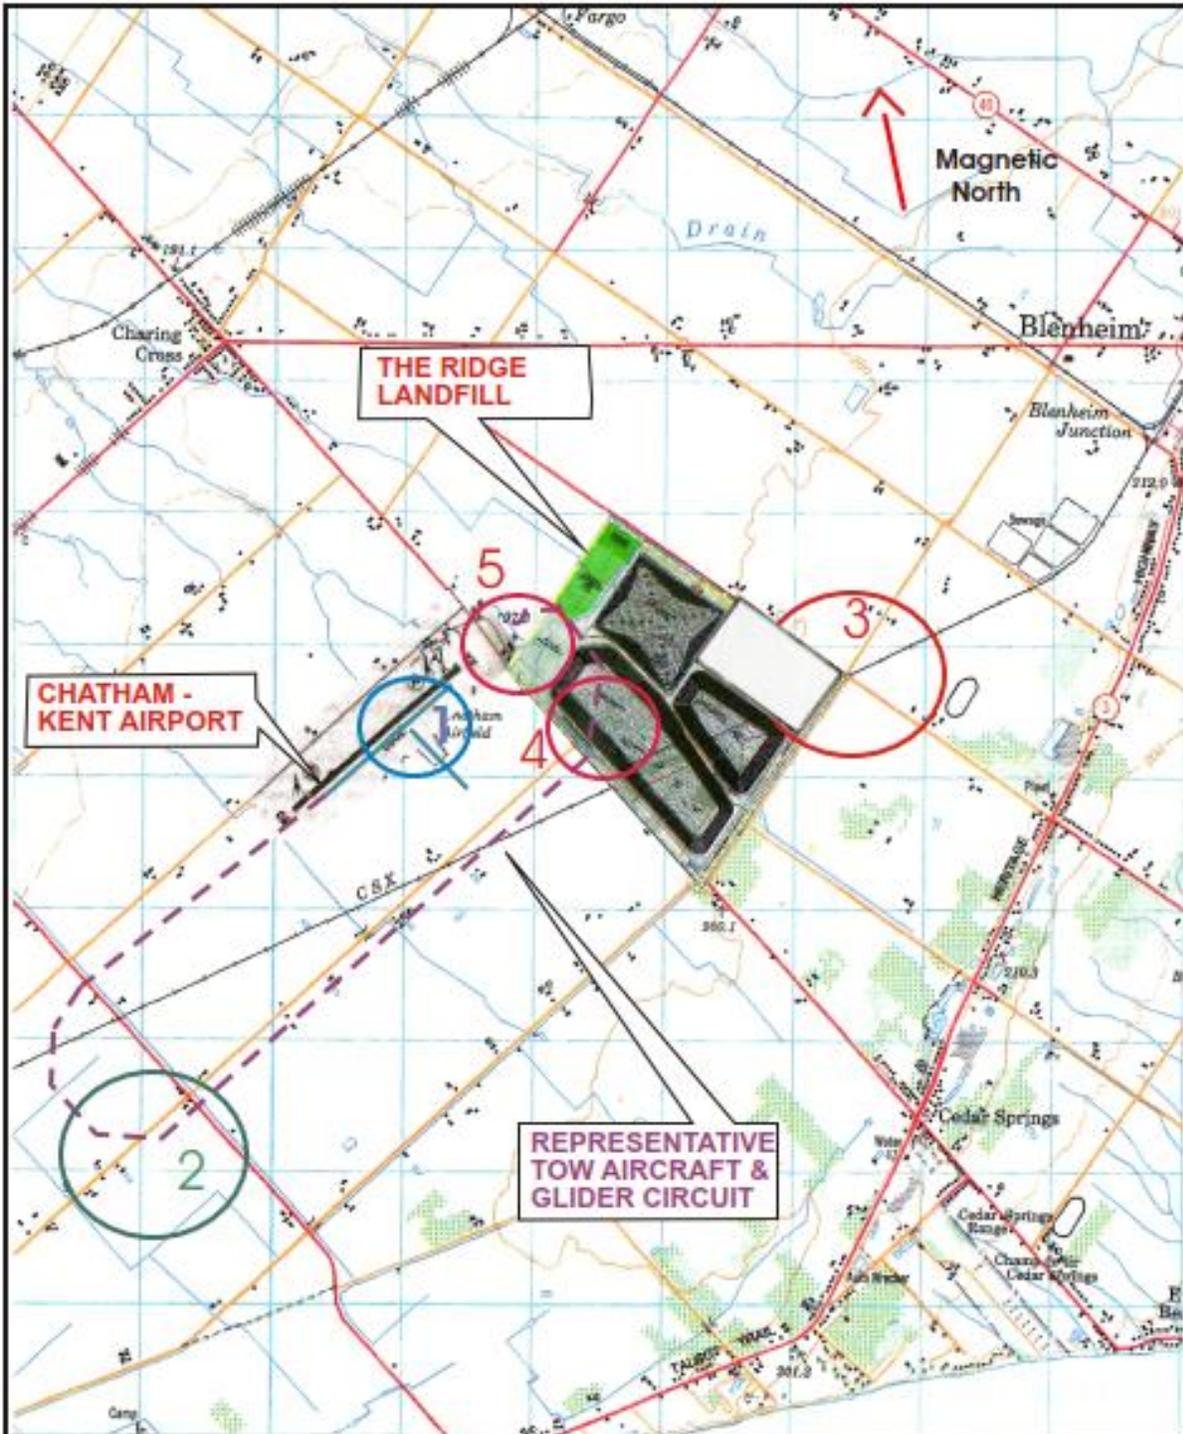
**MAP "C" CHATHAM- KENT MUNICIPAL AIRPORT  
AIR CADET FLIGHT PROCEDURES**  
(As Of February 23, 2019)

Figure 7 (Map C) outlines the various operating aspects of the Air Cadet flight towing and gliding operations, which consist of familiarization flying in the spring followed by the main operations that take place from September to November, with shut down over the winter. All flight operations normally take place south of the runway. On the map is shown the representative circuit pattern for tow aircraft and glider take-offs and landings on the parallel grass runway, that is beside and just south of the main paved runway.

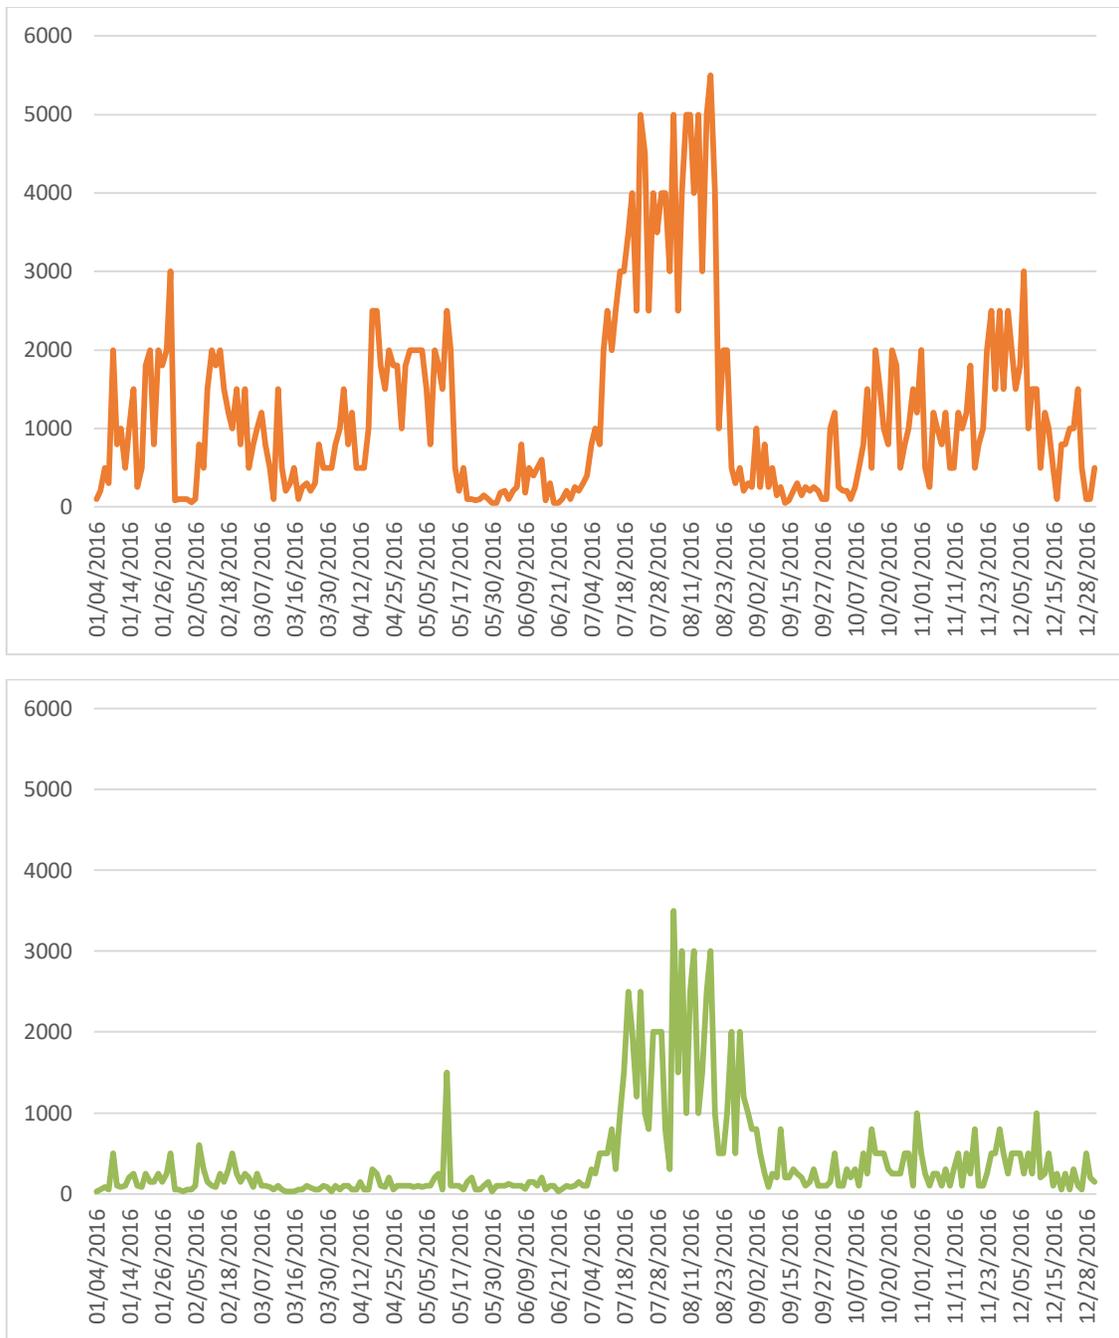
Figure 8. Number of gulls present at Ridge Landfill in 2016 when the controller arrived on site in the morning at 9:00 AM(upper panel) and number of gulls present when the controller left for the day at 5:00 (lower panel).

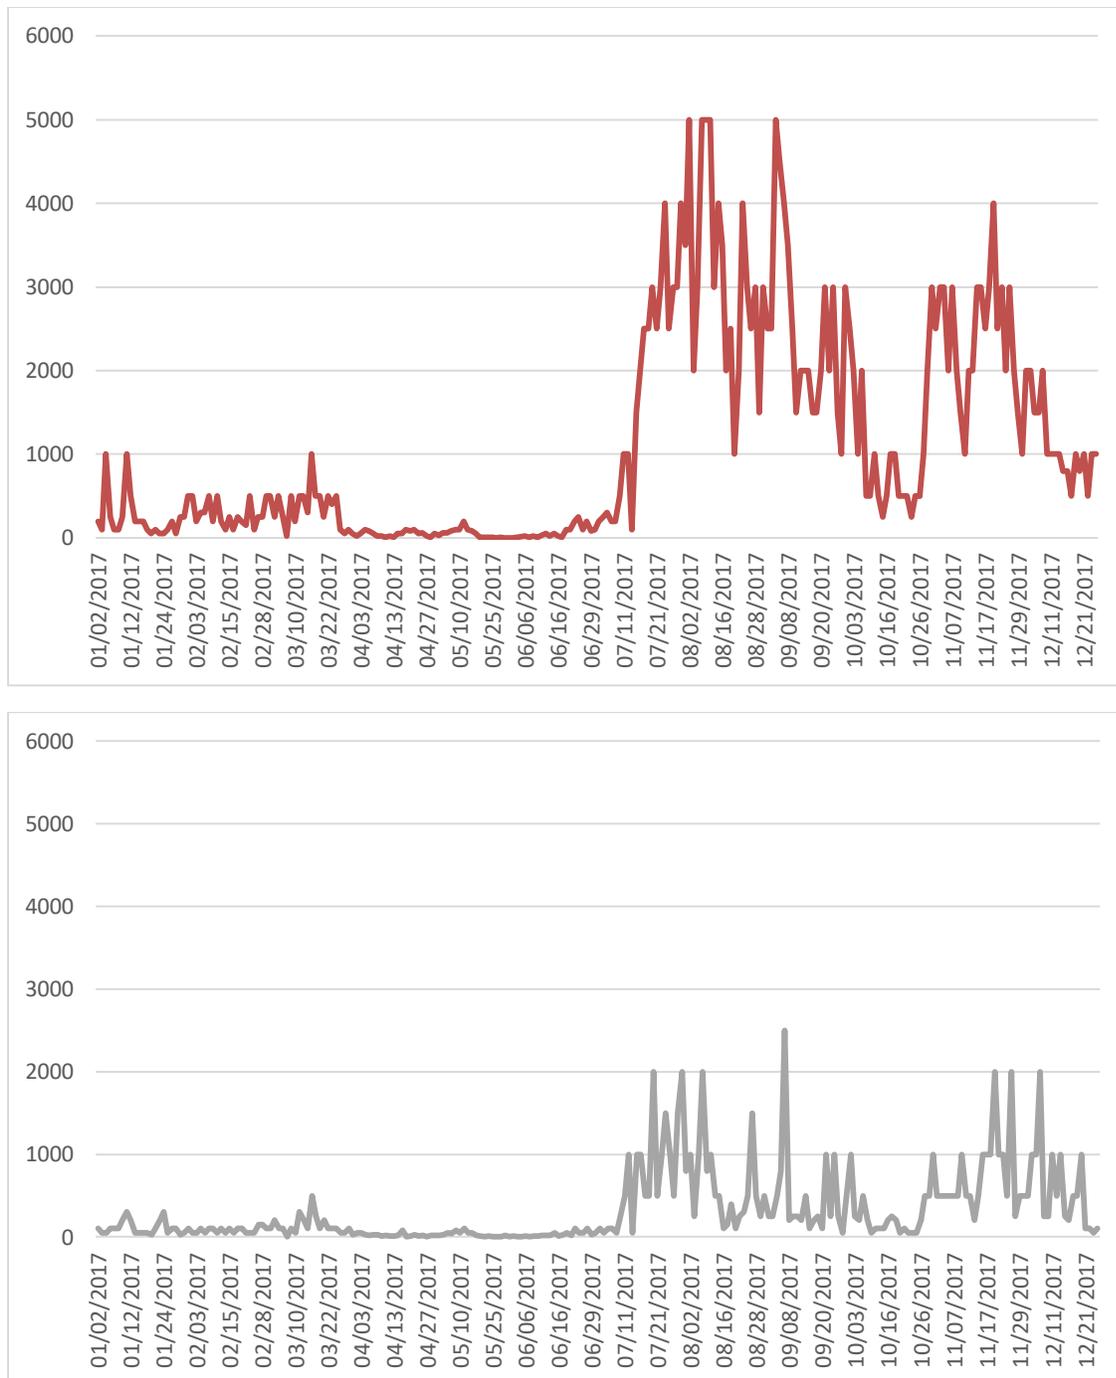
Figure 9. Number of gulls present at Ridge Landfill in 2017 when the controller arrived on site in the morning at 9:00 AM (upper panel) and number of gulls present when the controller left for the day at 5:00 PM (lower panel).

The daily controller records for 2017 are presented in Figure 9. The Peak numbers at the start of the controller's shift at 9:00 AM were again in the July-August or early September period with numbers up to 5,000 gulls present at the landfill. Numbers were also high (up to 4,000) during the October-December period (upper panel). The numbers of gulls during the first half of 2017 were lower than in 2016. This is probably a result of the controller arriving on the site earlier in the day, often before the gulls arrived.

The numbers of gulls at the landfill at the end of the controller's shift at 5:00 PM were low for the first half of the year but increased during the July-early September period, as in 2016, with numbers reaching 2,000 to 2,500 (see lower panel). Substantial numbers remained during the October-December period, up to 2,000.
